PRELIMINARY FAULT INVESTIGATION
COTTONWOOD COMMONS
CITY OF SAN JACINTO
RIVERSIDE COUNTY, CALIFORNIA

Project No. 601977-001

October 10, 2007

Subject: Preliminary Fault Investigation, Cottonwood Commons, Assessor Parcel Number 431-110-008, NWC of Sanderson and Cottonwood Avenue, San Jacinto, California

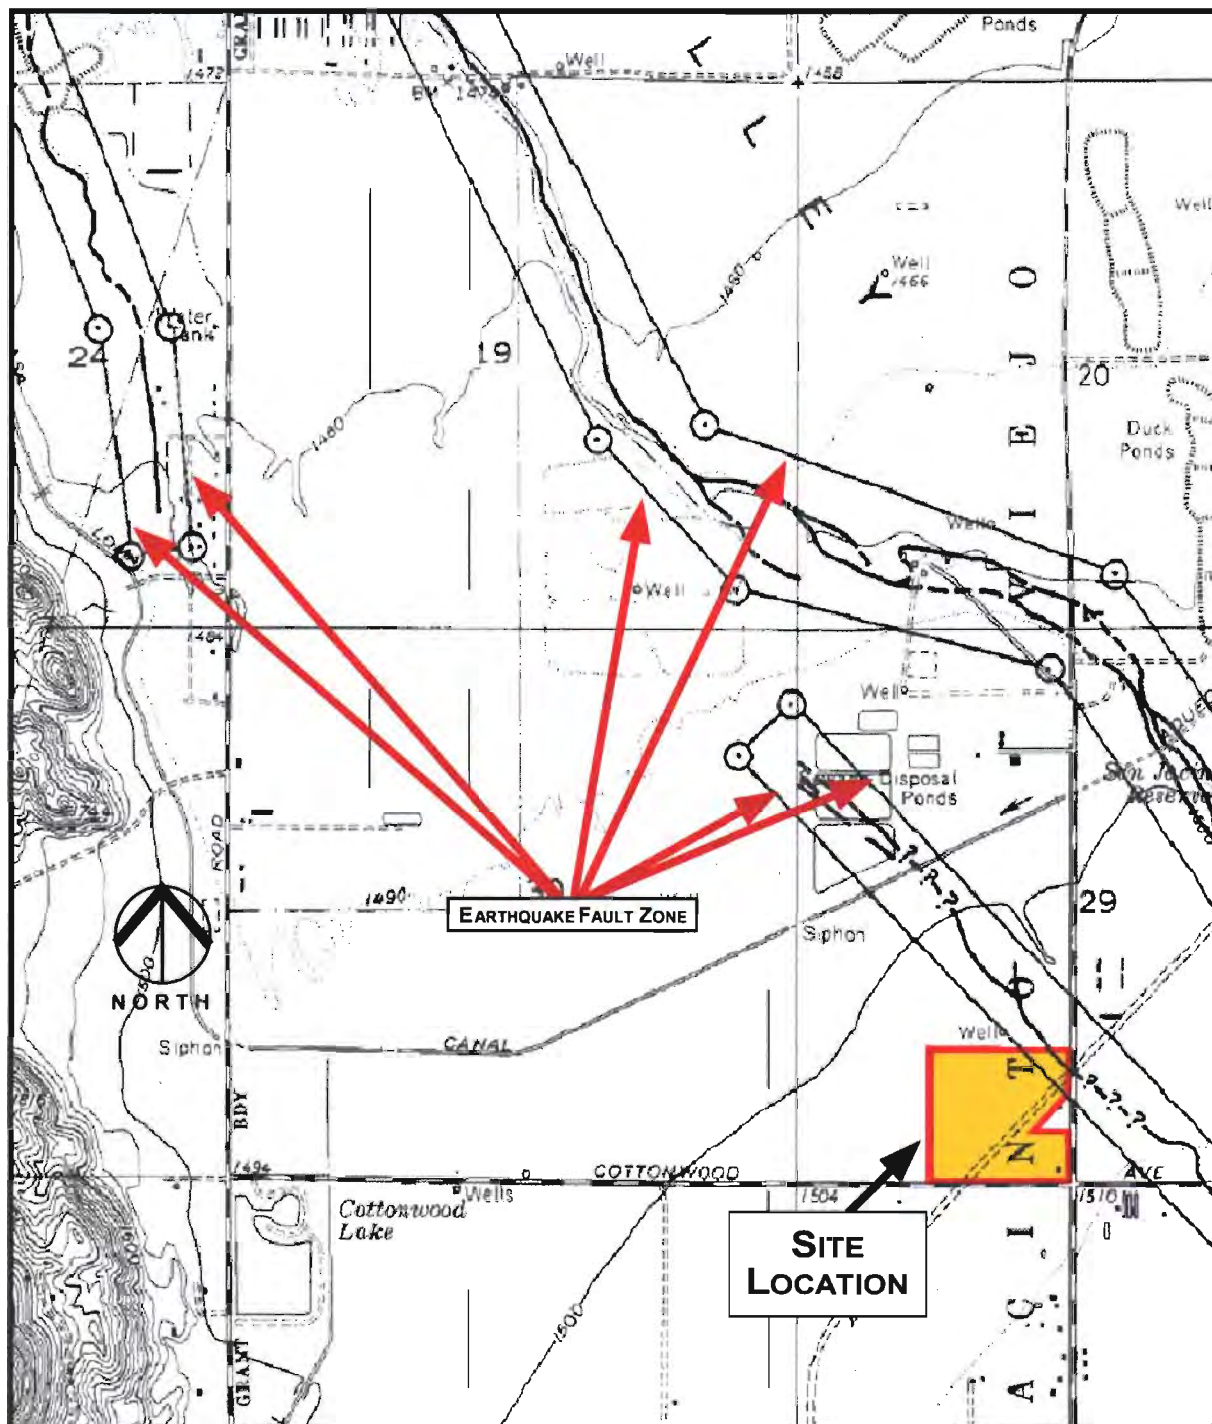
Figure No. 3

As depicted on Plate 1 and Figure 3, an Alquist-Priolo Earthquake Fault Zone (A-P Zone) transects the northeast portion of the property. Earthquake Fault Zones are believed to contain “active faults”, unless proven otherwise by a detailed investigation. The California Geologic Survey (CGS) defines an “active fault” as one that has had surface displacement within the Holocene Epoch (roughly the last 11,000 years). Accordingly, the primary purpose of this investigation was to determine the suitability of the site for commercial development from the standpoint of potential surface fault rupture. Additional geotechnical studies are recommended to properly evaluate engineering characteristics of the subsurface soils for foundation support.

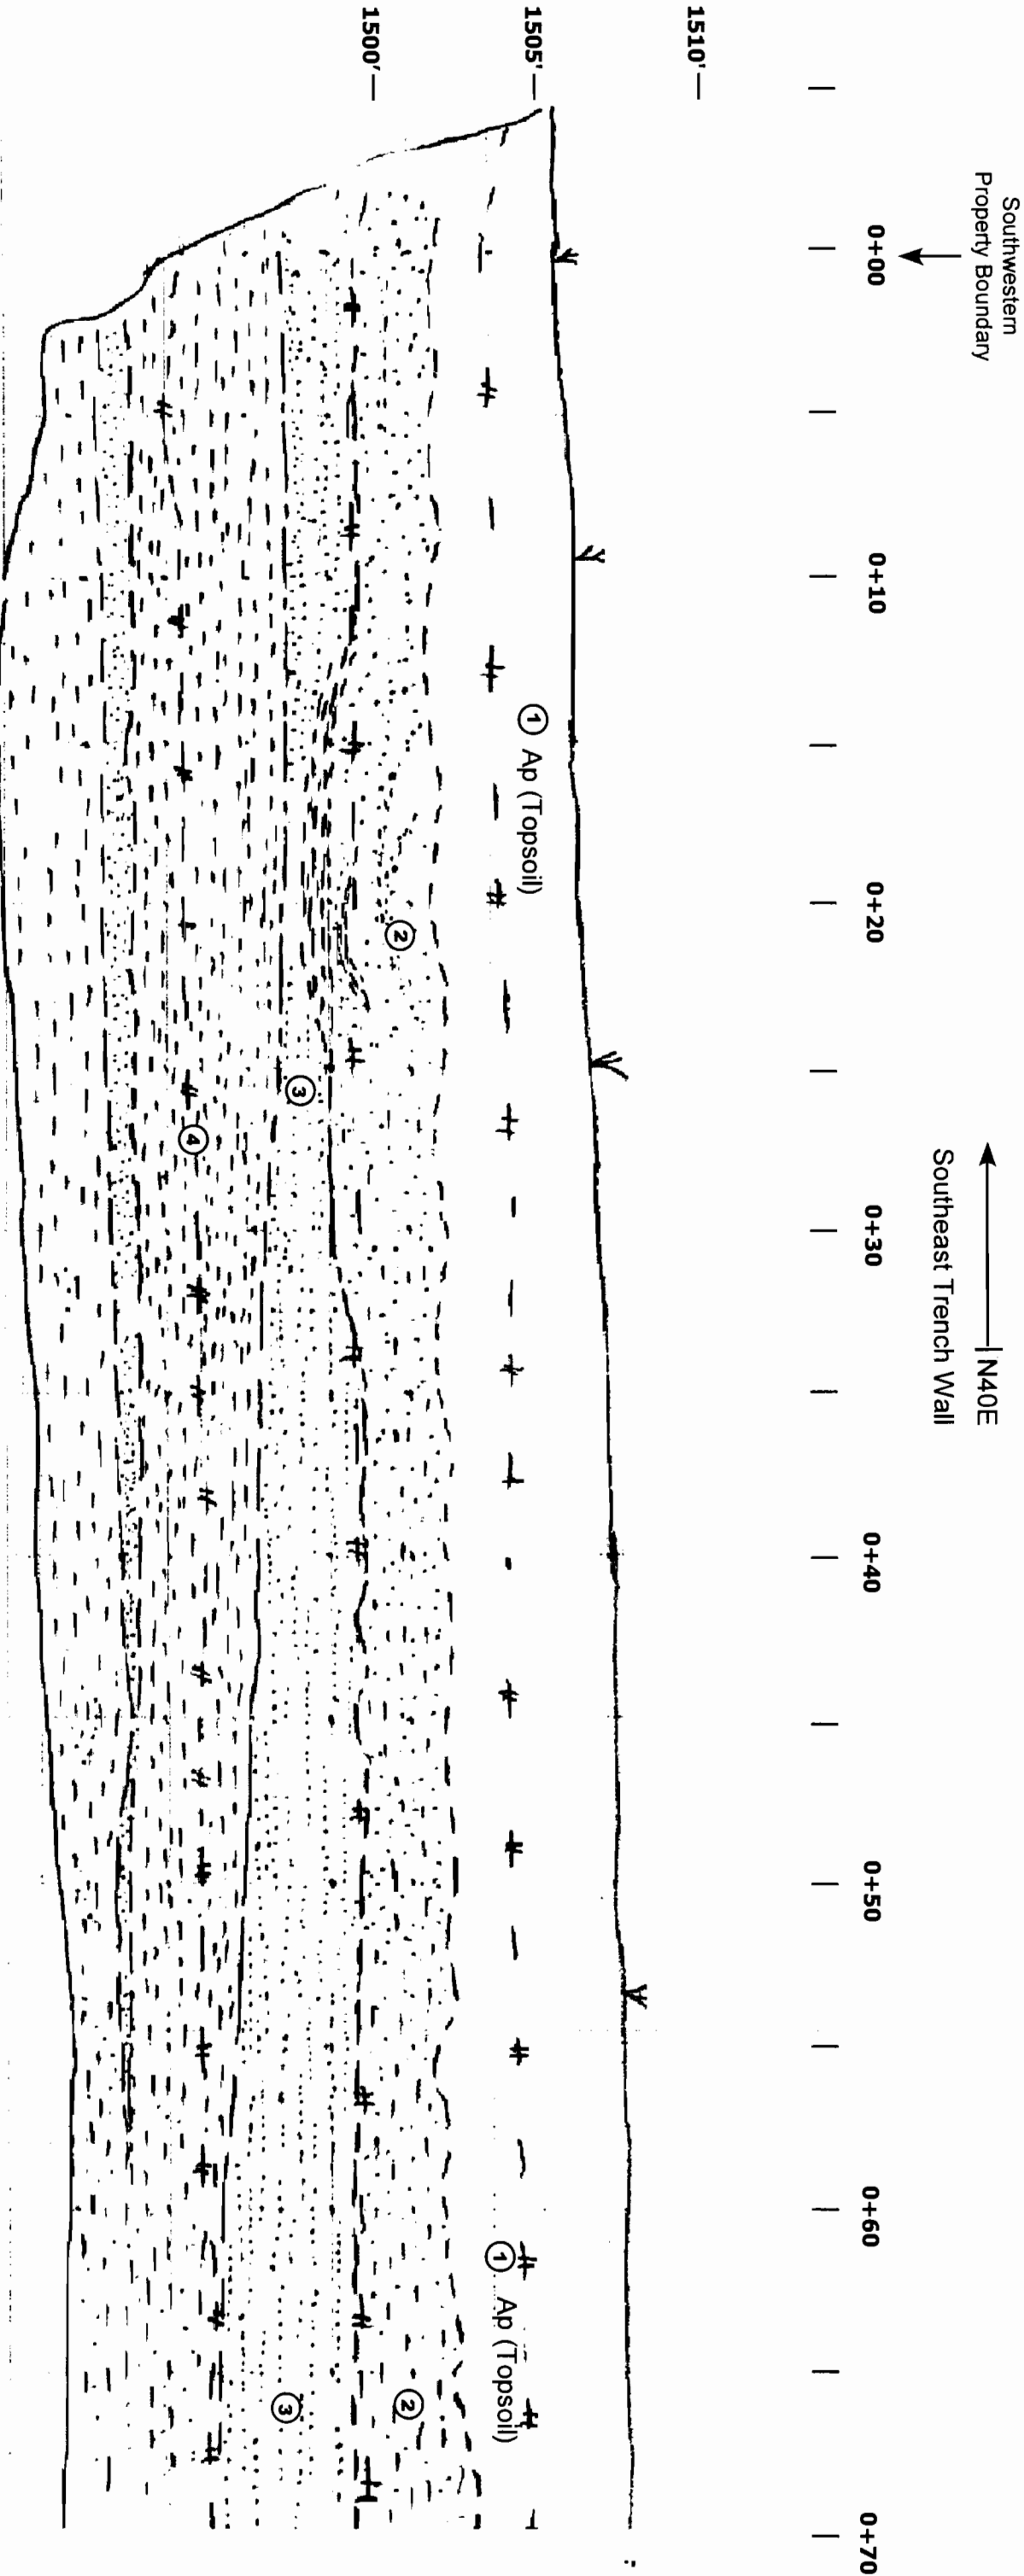
Log of Trench FT-1
Cottonwood Commons Fault Investigation
Riverside County, California

Fault Trench 1 (Map Symbol FT-1) - Fault Trench FT-1 was excavated to a maximum depth of 16-18 feet below ground surface (bgs), and a length of approximately 330 feet. FT-1 was excavated across the on-site portion of the state mapped Alquist-Priolo Earthquake Fault Zone (A-P Zone) at that location (see Plate 1). FT-1 trends N45E and the southeast wall was logged. Evidence of past seismic activity is identified between Station 1+00 through Station 1+20, as depicted on the trench logs. Several faults, with variable offsets, were identified within a 20-foot wide fracture zone. The majority of the faults can be traced

The main fault strikes 45 degrees northwest and dips approximately 70 to the northeast. No evidence of faulting was observed outside of the area identified on the log of trench FT-1.
