June 27, 2022

Subject: Vernal Pool Assessment for the San Jacinto Cultivation Farm Project

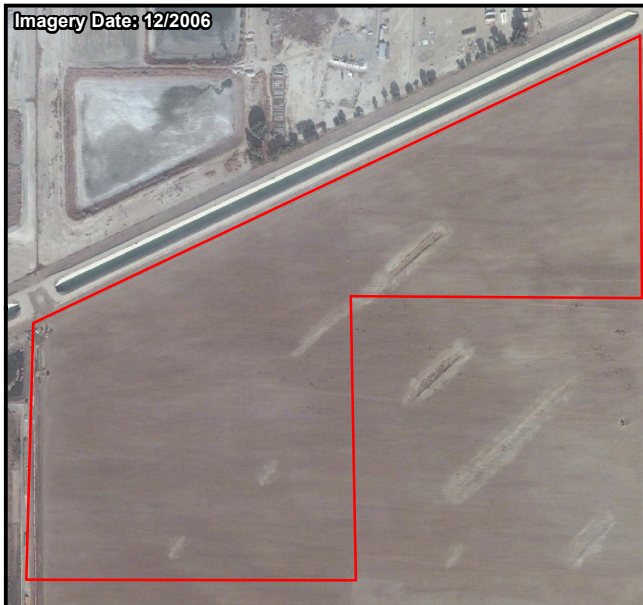
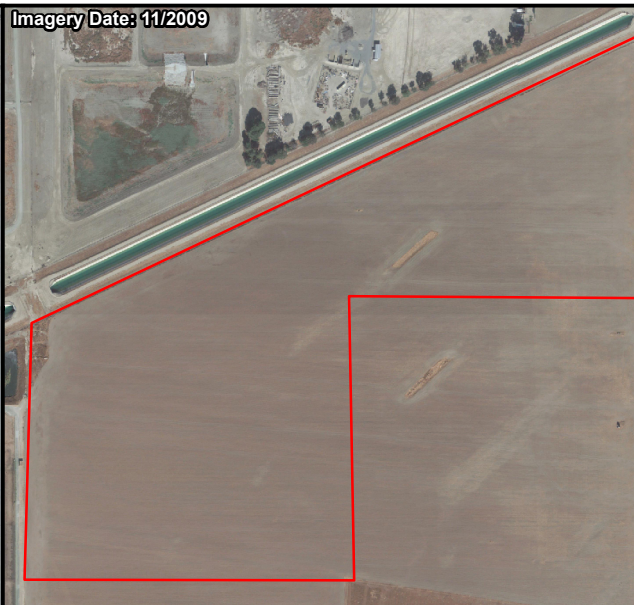
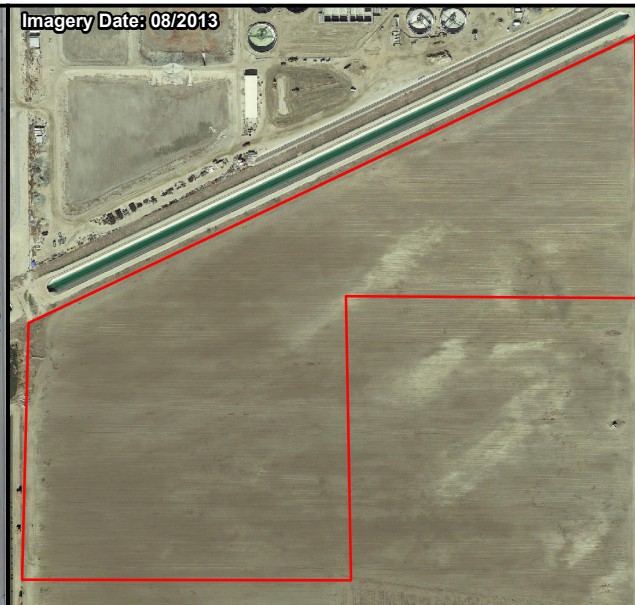
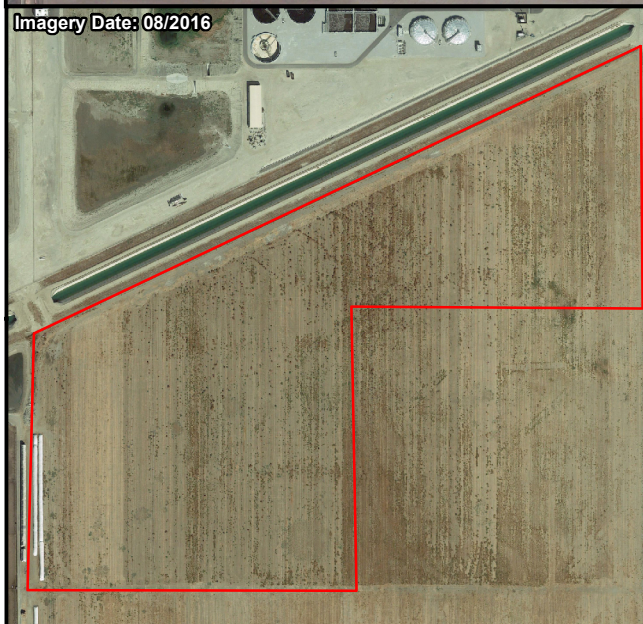
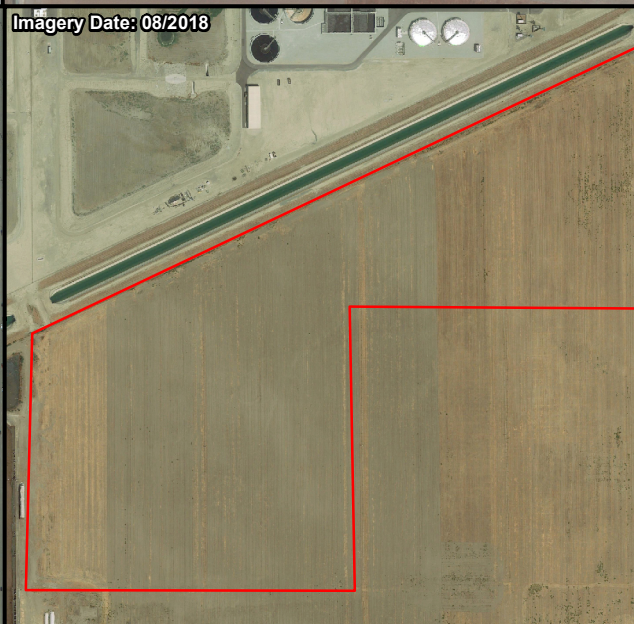
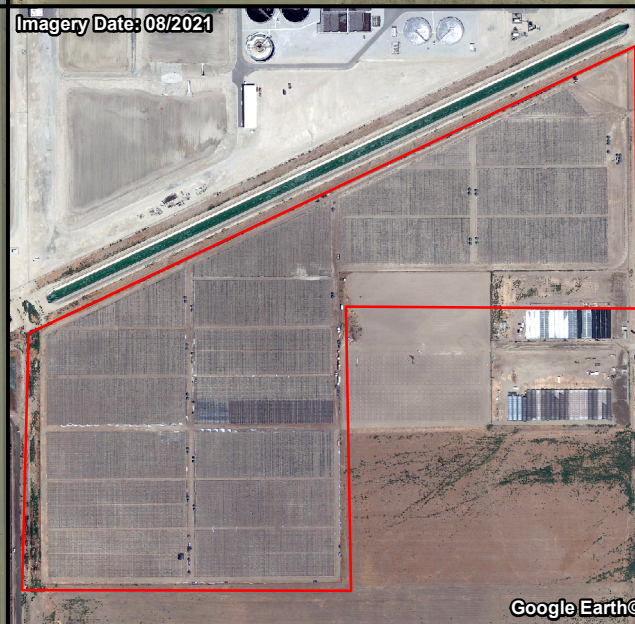
Figure 2
San Jacinto Cultivation Farm Project
Historical Aerial Imagry

Historical aerial imagery was reviewed over the past 15 years in order to determine areas where potential vernal pools may have occurred (Attachment 1: Figure 2 – Historical Aerial Imagery). No vernal pools or areas that could support vernal pools were observed in the historical aerial images over the past 15 years.

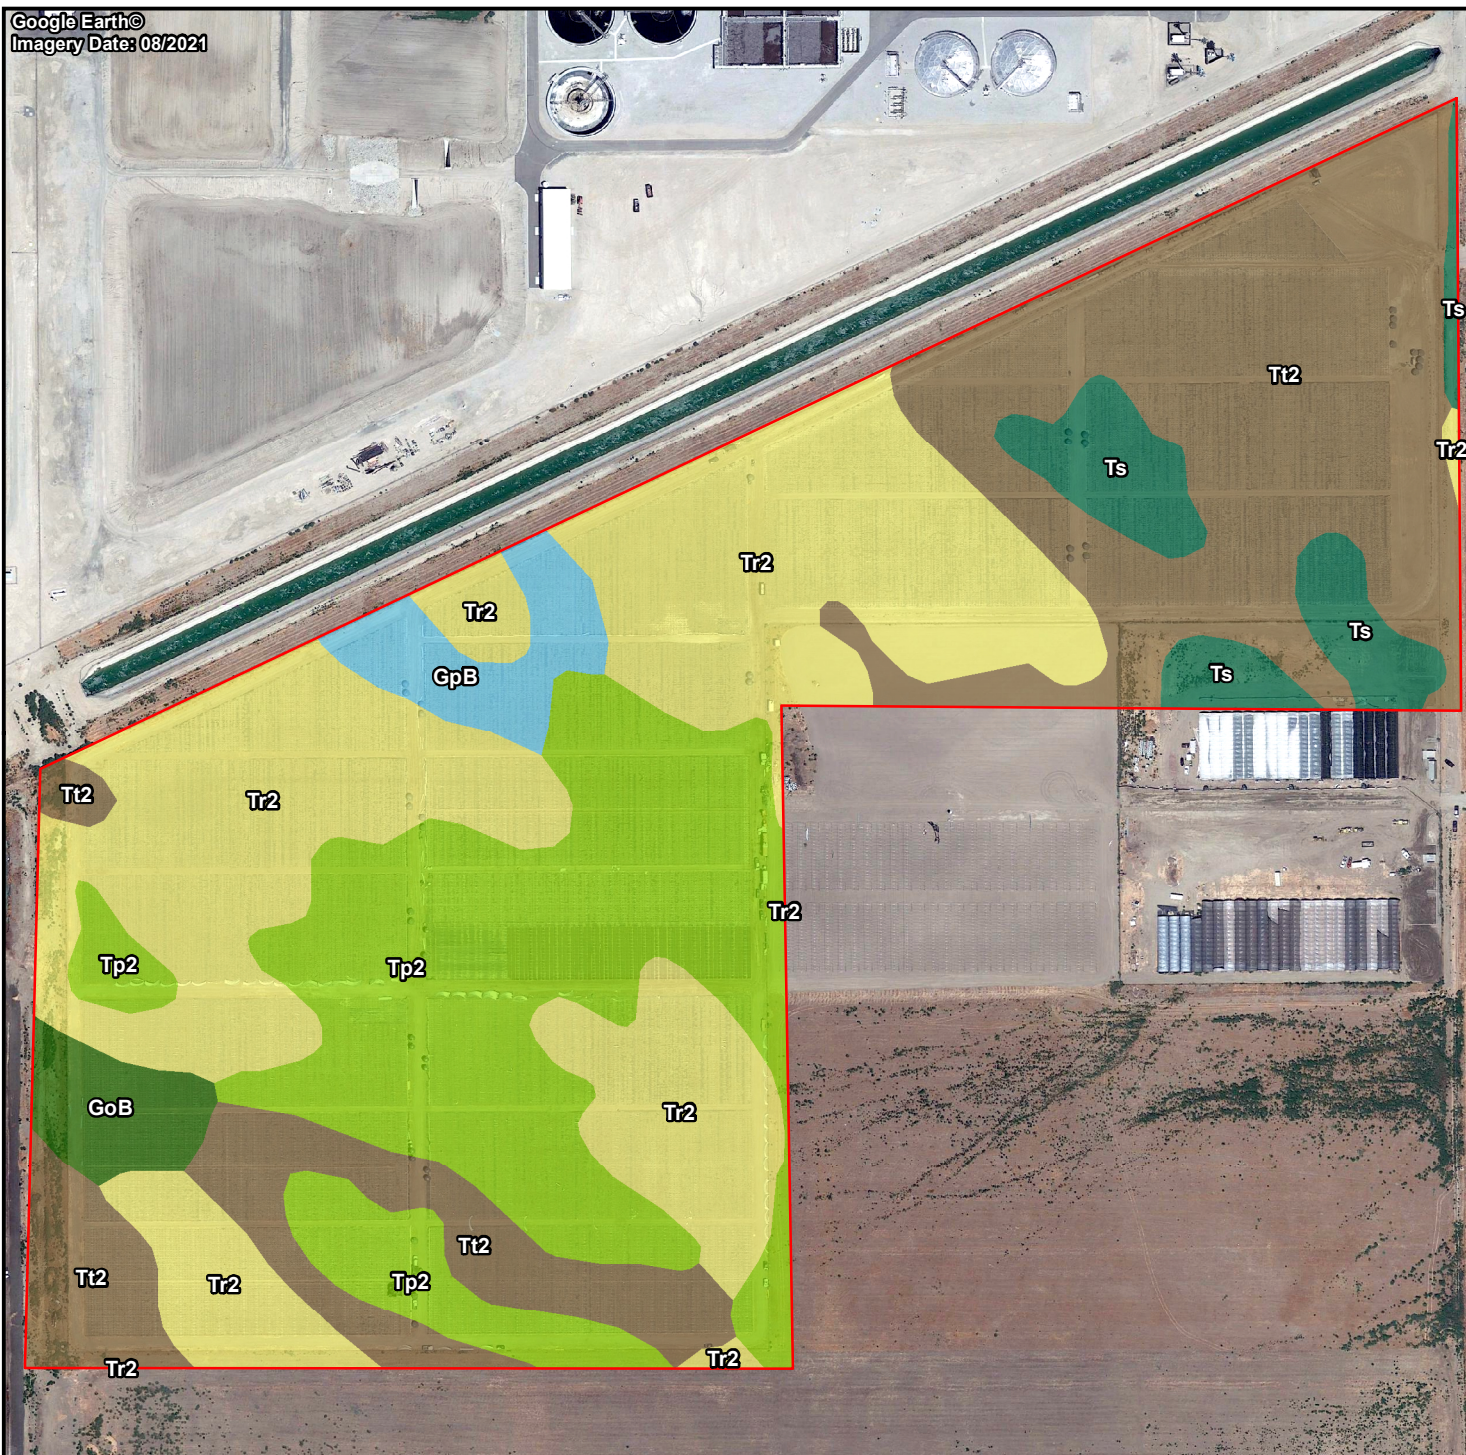
Figure 3
San Jacinto Cultivation Farm Project
USDA Soils

According to the results from the USDA NRCS Web Soil Survey (USDA 2022), the Project site is located in the Western Riverside Area, CA679 part of the soil map. Six soil types are known to occur within and/or adjacent to the Project site (Attachment 1: Figure 3 – USDA Soils Map). No hydric soils occur within the Project site. These soil types are described below.

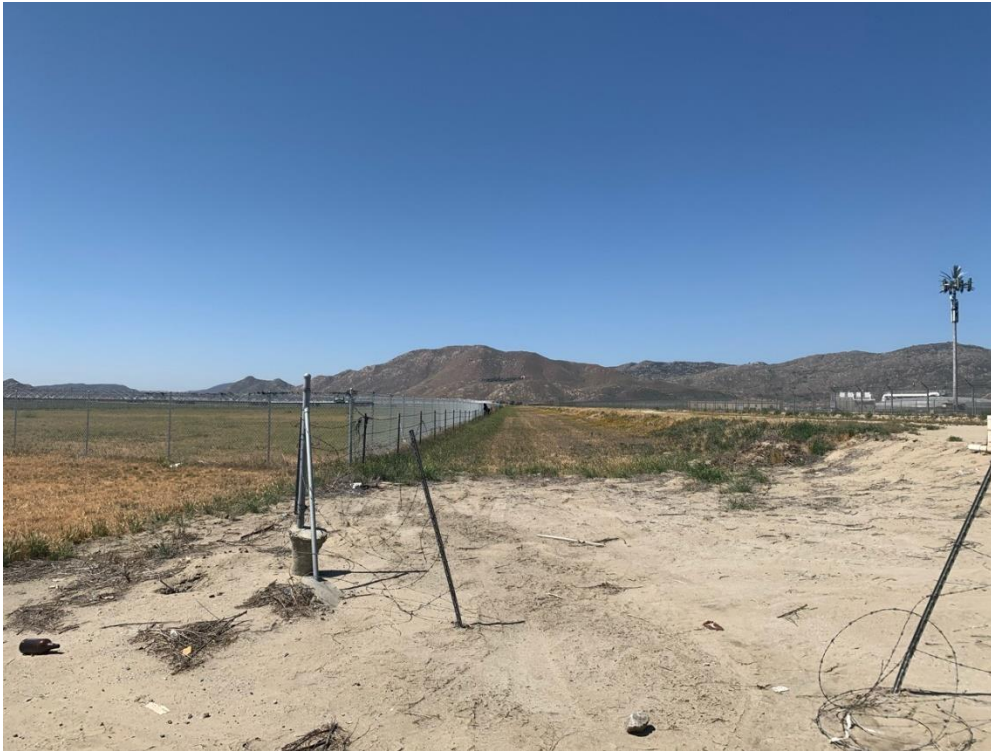
Photo 1.

Northern boundary of the Project site between the canal to the north and the site. There is no connectivity from the canal into the site. Photo is facing west.

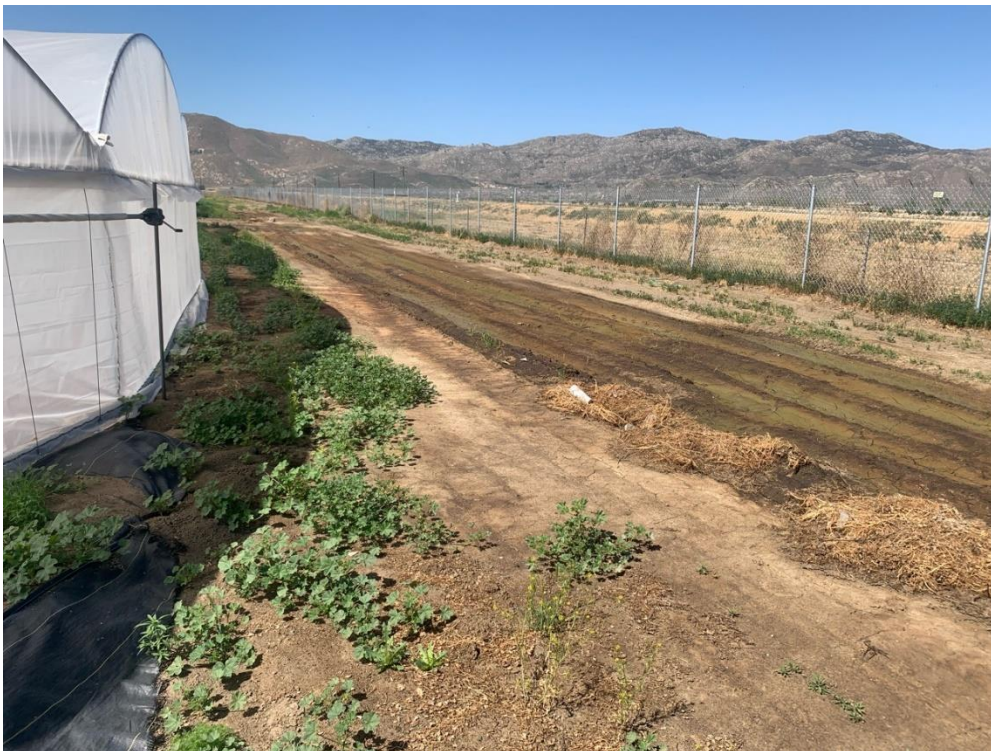
Photo 2.

Photo showing area along northern access road. No vernal pools or indicative species were observed along the road. Photo is facing northwest.

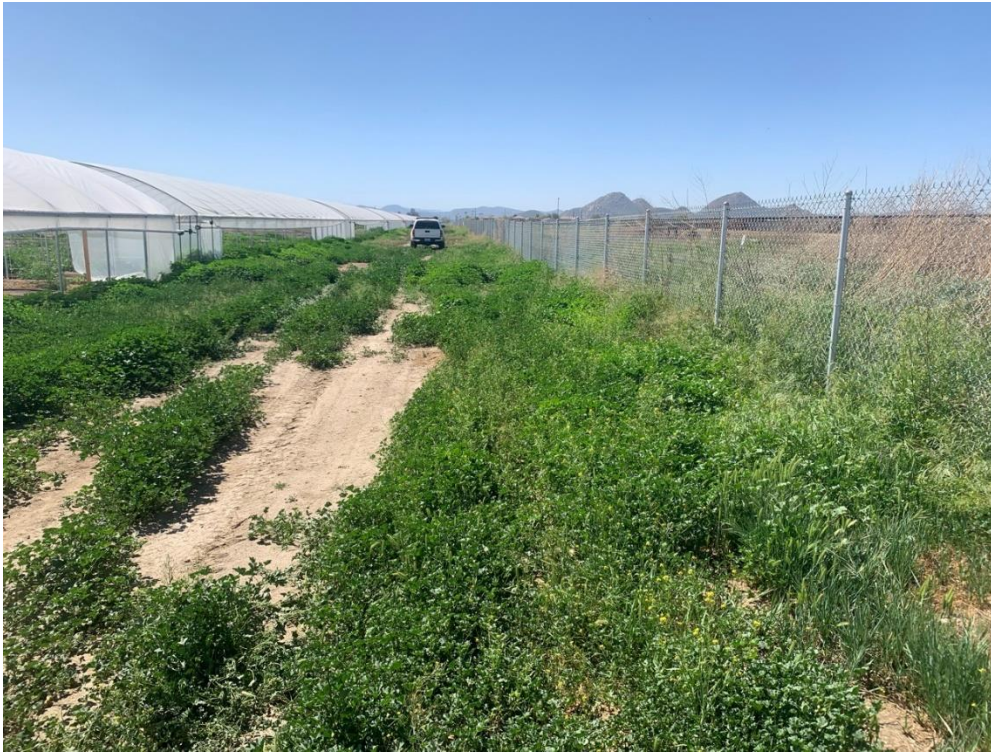
Photo 3.

Access road along the western boundary of the site. No potential vernal pools were observed throughout the road or adjacent to the road. Photo is facing south.

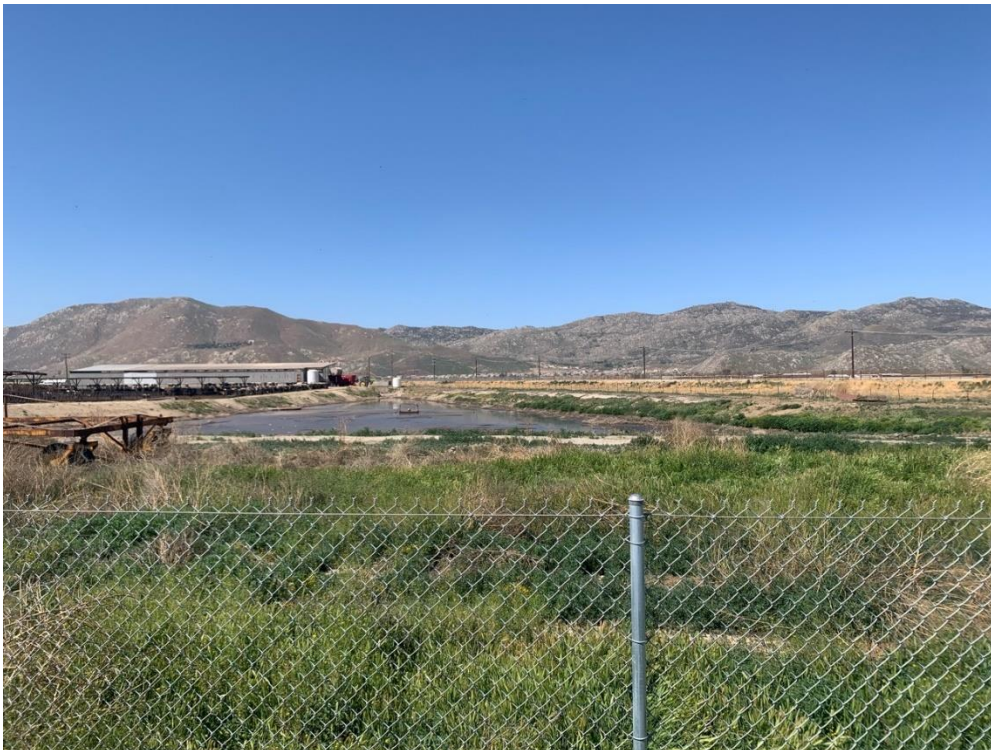
Photo 4.

Large retention pond located within the dairy farm to the west of the site. There is no connectivity between the pond and the Project site. Photo is facing west.

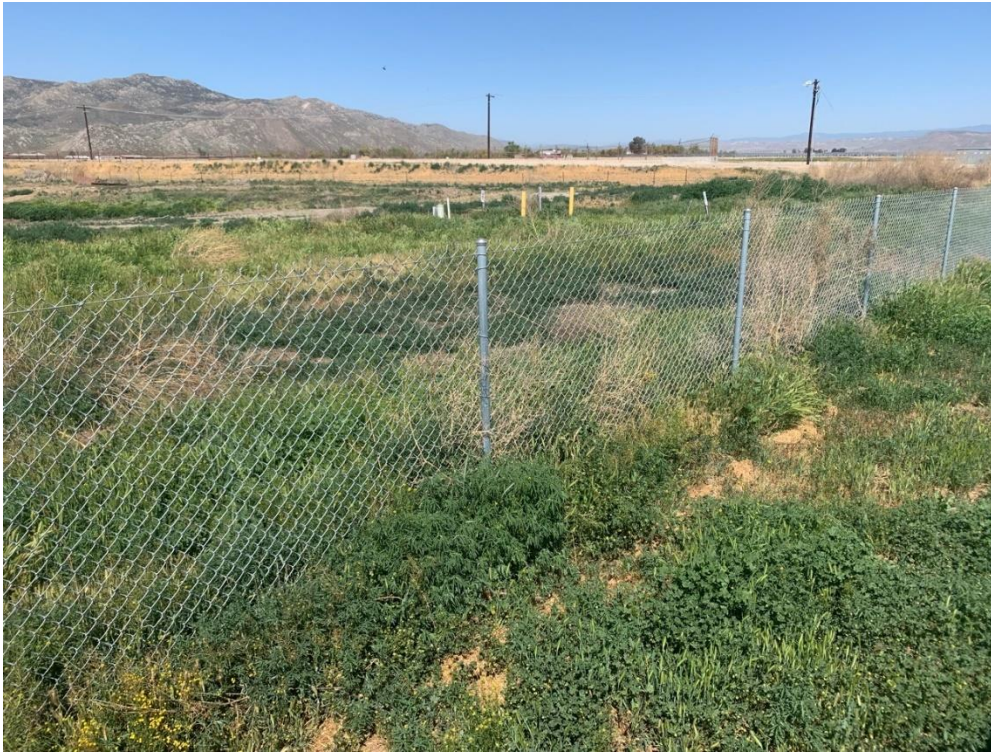
Photo 5.

Photo showing the lack of connectivity between the retention pond and the Project site. Photo is facing northwest.

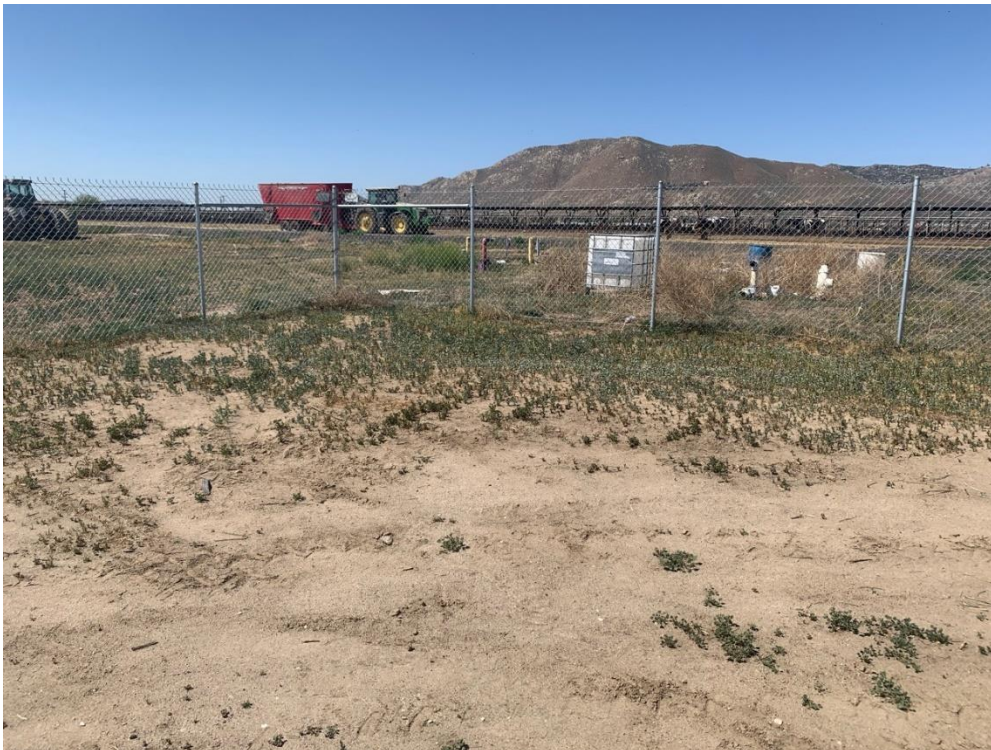
Photo 6.

Southwest corner of the Project site. Photo shows no potential vernal pools within or adjacent to the Project site. Photo is facing southwest.

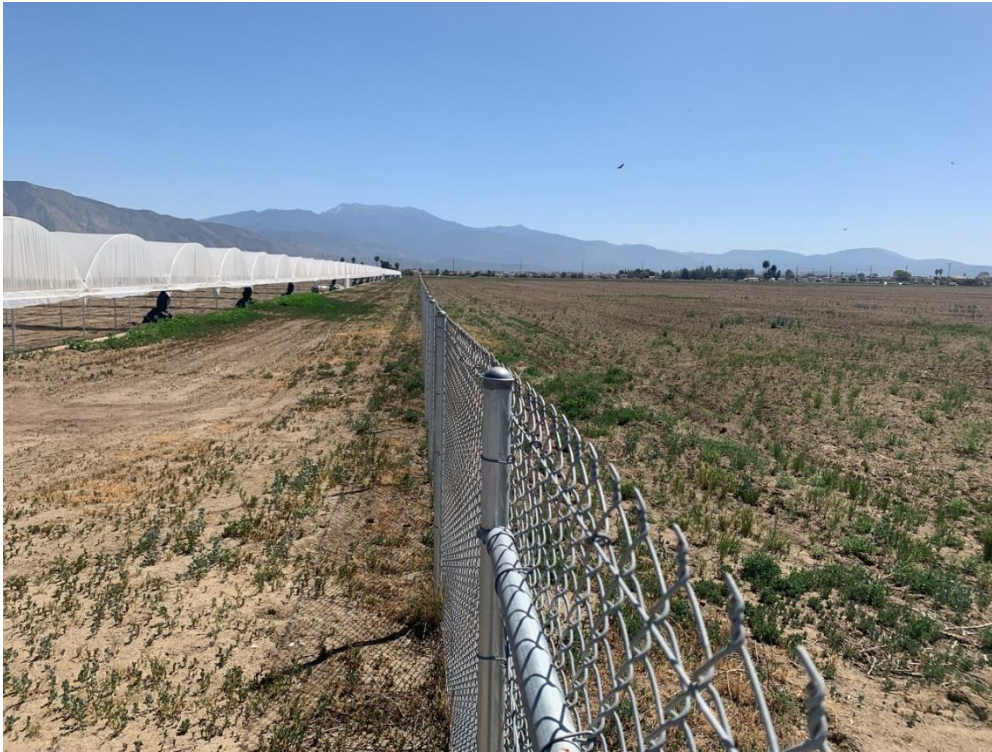
Photo 7.

Overview of Project site and the adjacent lot along the southern portion of the site. No features or connectivity occur within or adjacent to the site. Photo is facing east.
